# FOR WAYLAND ARMS SLAB REPAIR & SEISMIC UPGRADE RFQ

<b>Project Name:</b>	Wayland Arms Apartments - Settlement Monitoring	<b>Report:</b> 003	
<b>GeoDesign #:</b>	KCHA-13-04	<b>Date:</b> 06/06/2024	
<b>Reports with Unresolved Nonconformance Issues:</b>		<b>Permit:</b>	
<b>Distribution:</b>	Heath MacCoy <HeathM@kcha.org>		
	David Curtice <DavidC@kcha.org>		
	Kevin Johnson <KevinJ@kcha.org>		
	Patrick Kaapana <PatrickK@kcha.org>		
	Michael Cuadra <MichaelC@kcha.org>		
	<b>Weather:</b> NA, indoors	<b>Arrival/Departure:</b> 0815/0840	<b>Prepared By:</b> Vinnie Oskierko
<b>Attachments:</b>	<input checked="" type="checkbox"/> Site Plan(s)	<input type="checkbox"/> Density Test Summary	<b>Signature:</b>
	<input type="checkbox"/> Installation Records	<input type="checkbox"/> Other	<b>Reviewed By:</b>

**SUMMARY OF CRACK MONITORING GAGE INSTALLATION AND READINGS:**

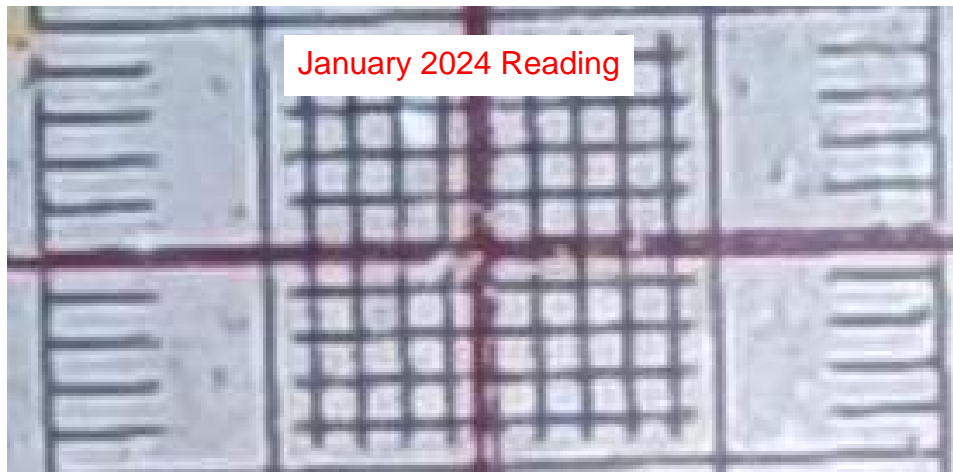
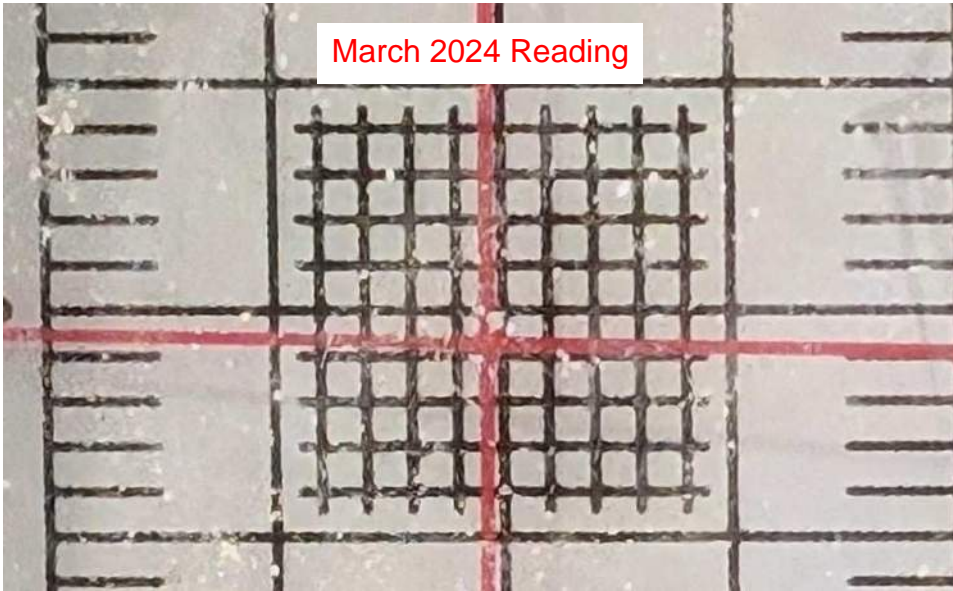
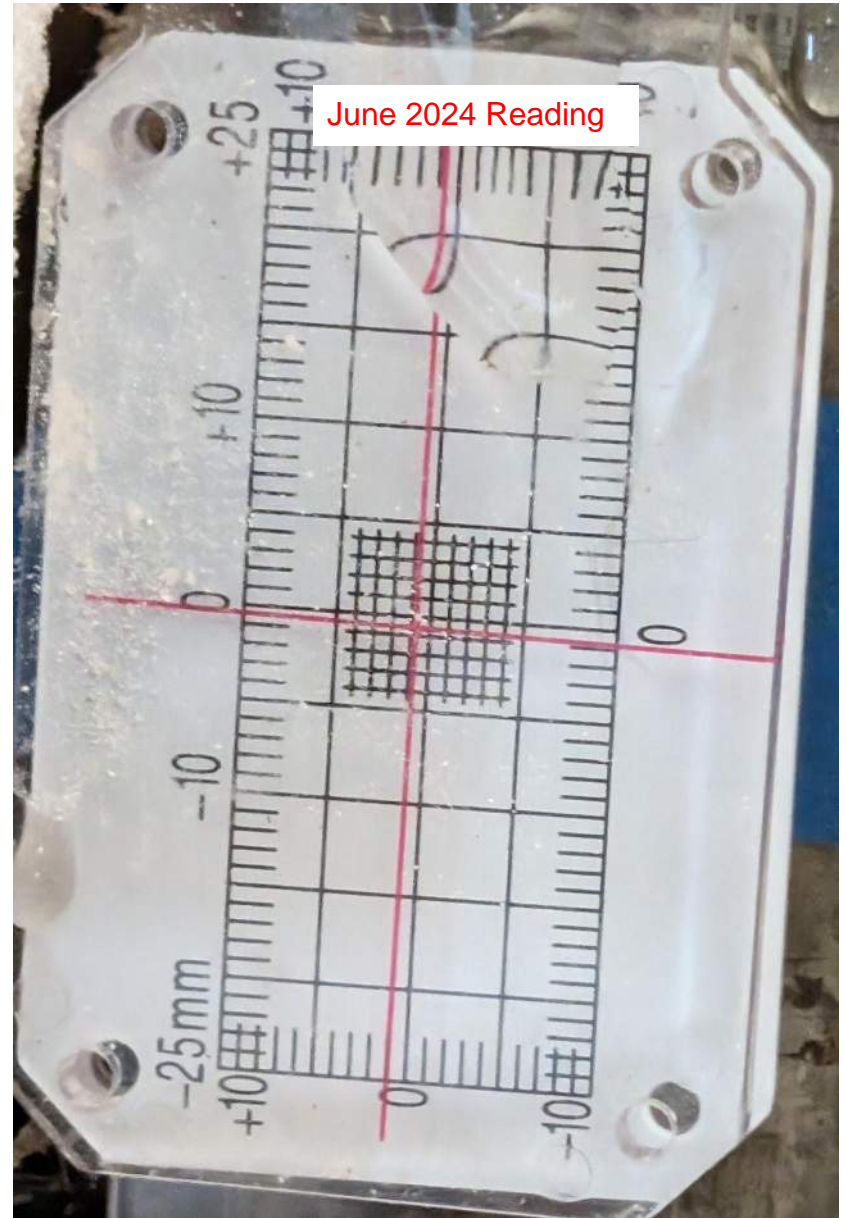
FIGURE 2

MP-1 - Suite 100 central wall opposite interior hallway between floor and wall stud. Wall studs are hanging from 2nd floor joist and there is an existing gap between the floor slab and base plate.

January 2024		March 2024		June 2024	
	Horizontal	Vertical	Horizontal	Vertical	Horizontal	Vertical
MP-1	0.0	0.0	0.00	-1.00	-1.0	-0.5
MP-2	0.0	0.0	0.0	0.0	0.0	0.0
MP-3	0.0	0.0	0.0	0.0	0.0	0.0
MP-4	0.0	0.0	0.0	0.0	0.0	0.0
MP-5	1.5	0	1.0	-1.0	1.0	-1.0

Based on the first round of readings, and this follow up reading, we do not have enough data to determine if the slab is stable. It is too early to determine if the slab requires stabilization. We recommend continuing to read the gages on a 3-month interval for the first year (until December 2024) and revise monitoring intervals based on past readings.

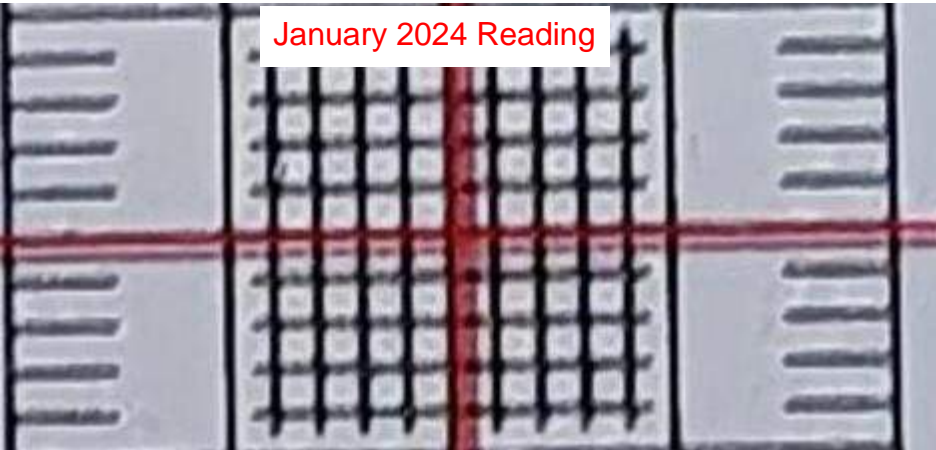
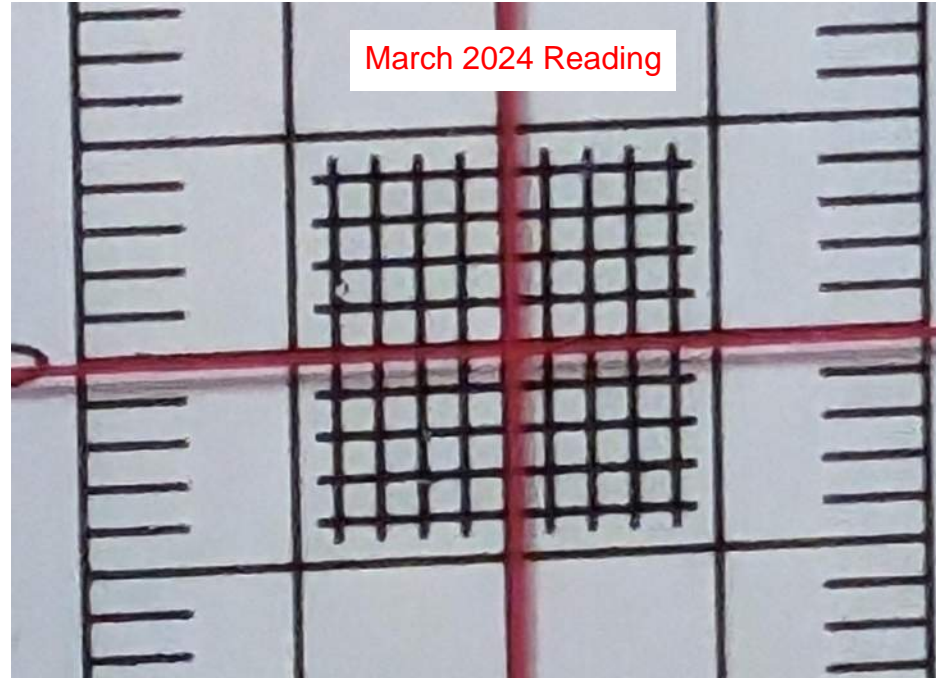
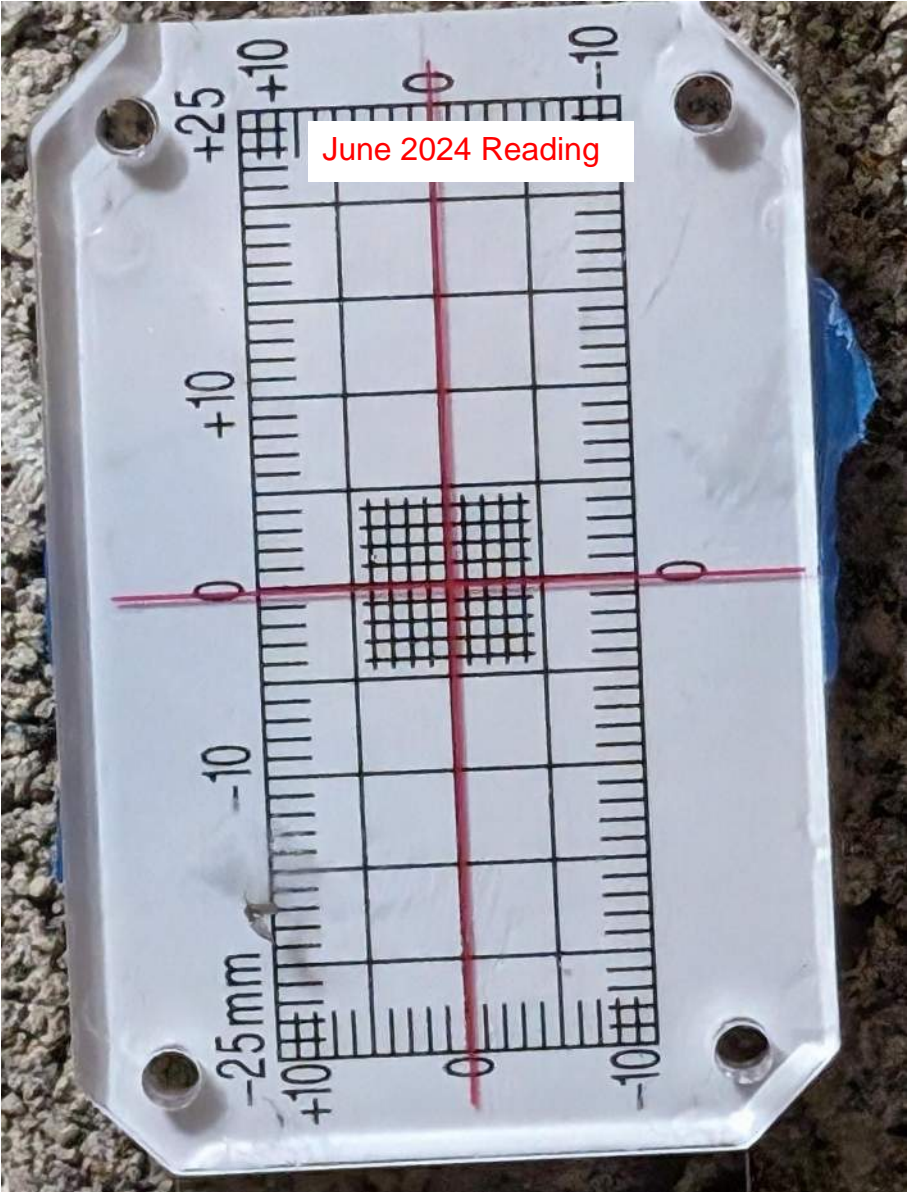
FIGURE 3

MP-2 - Mechanical room central wall opposite interior hallway, between floor and cinder block wall.

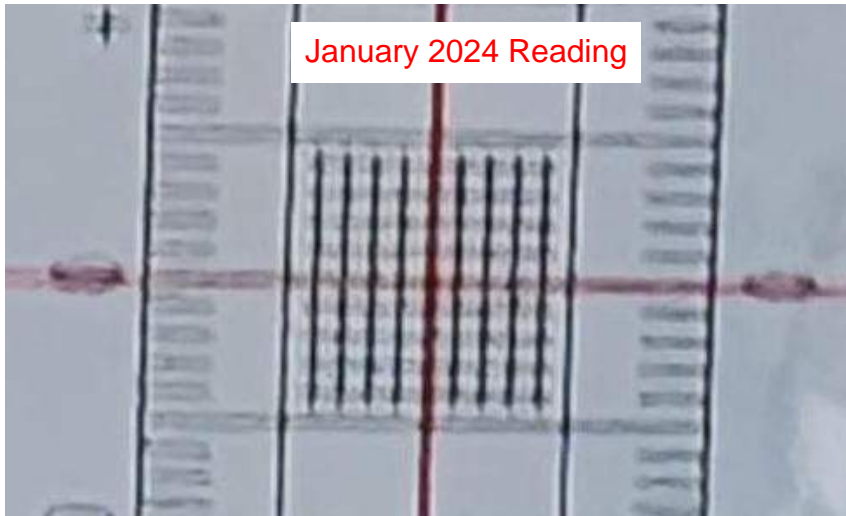
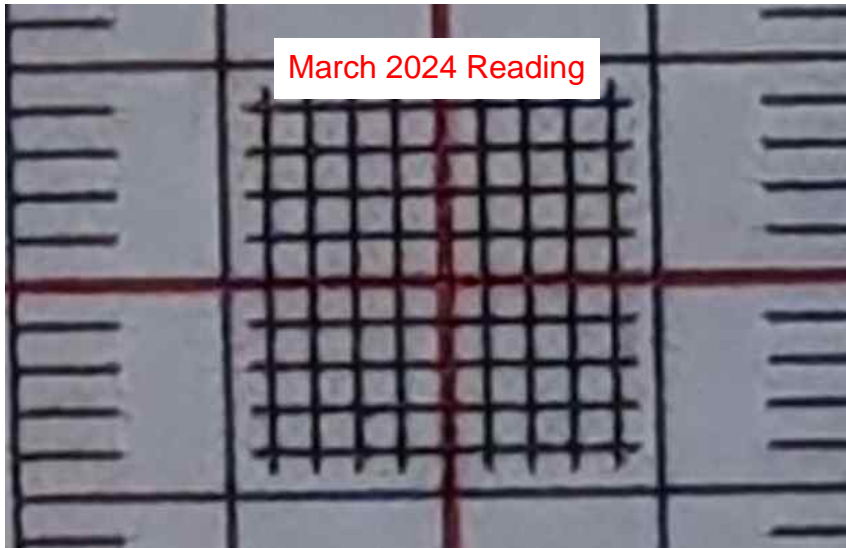
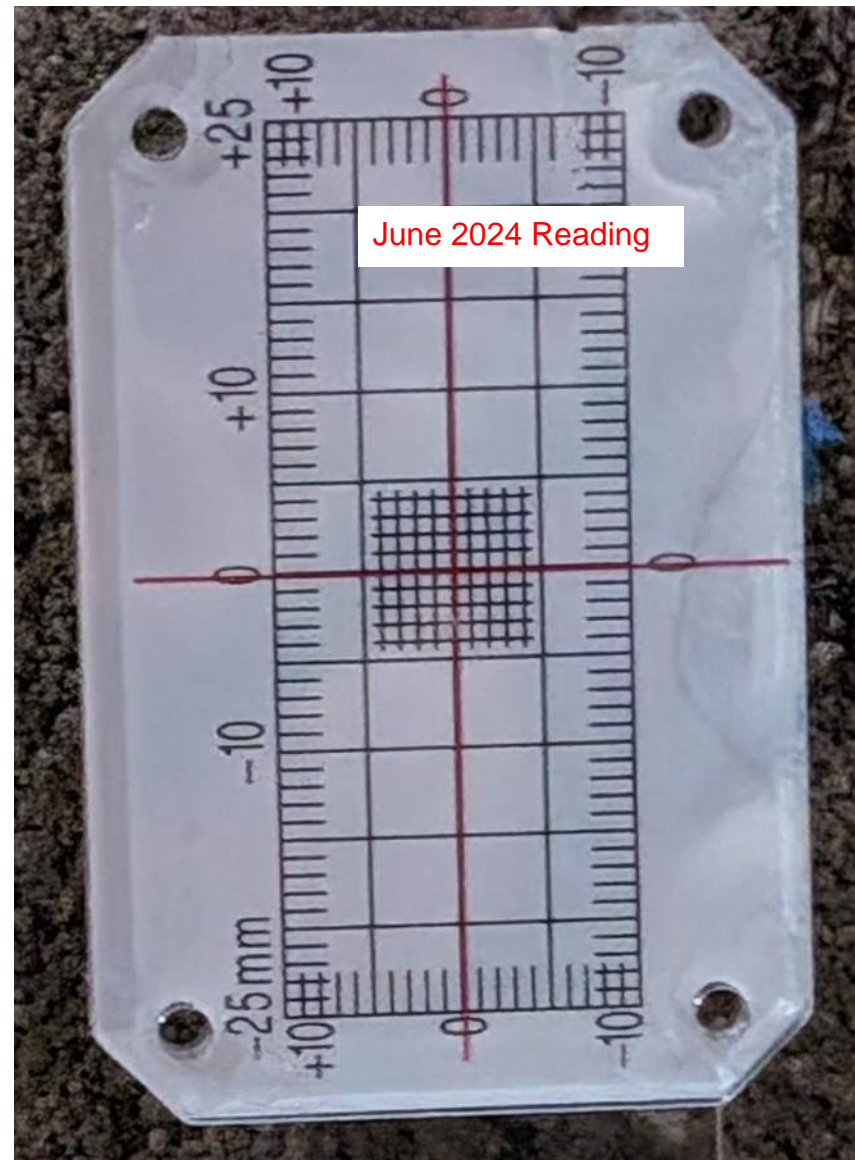
FIGURE 4

MP-3 - Mechanical Room north wall behind fire water pipes between floor slab and cinder block wall.

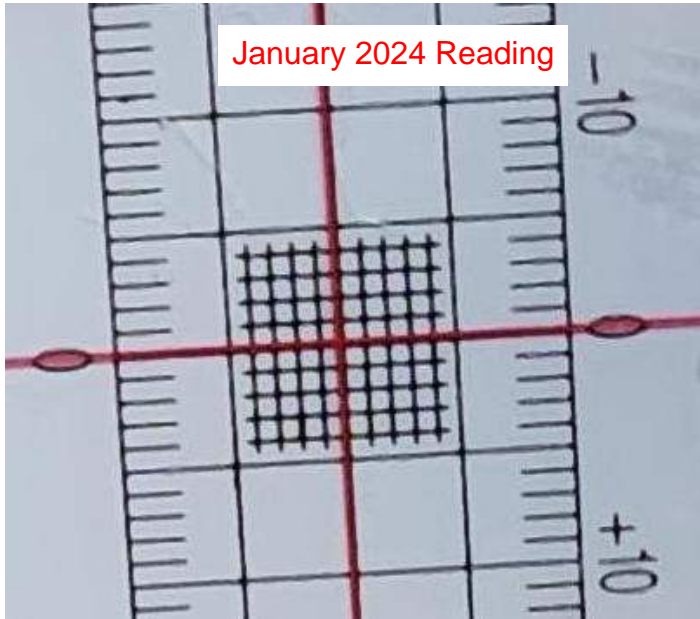
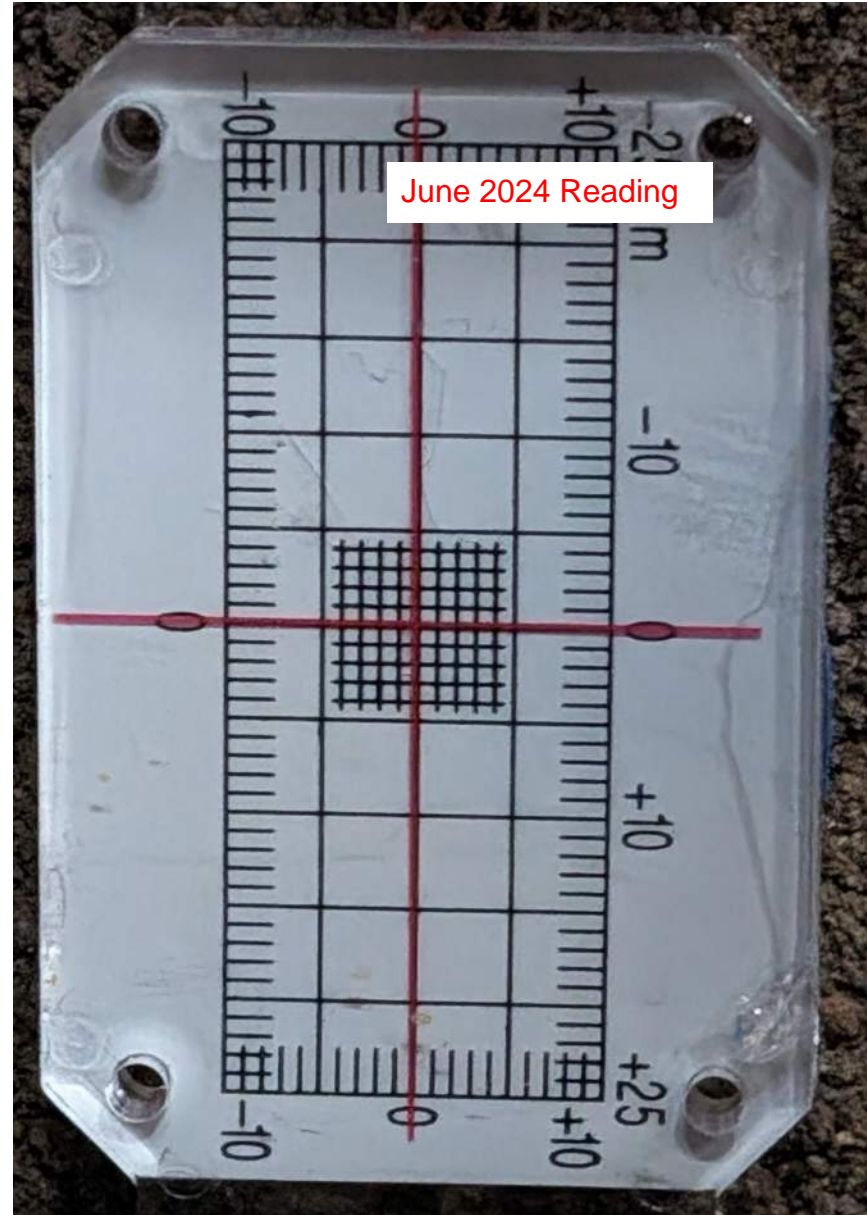
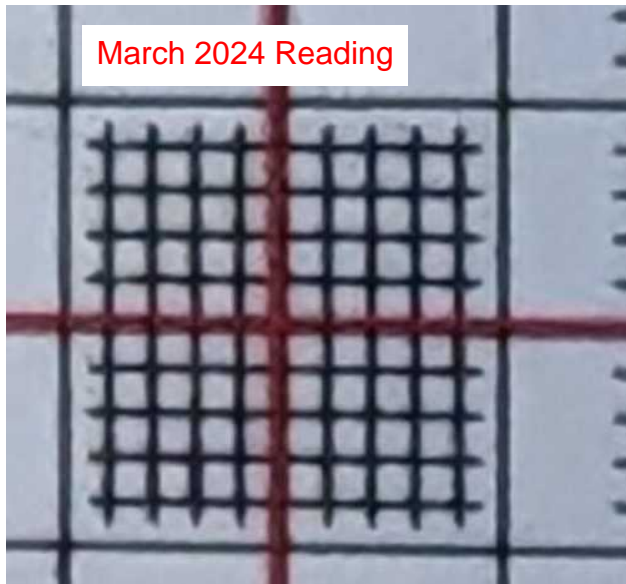
FIGURE 5

MP-4 - Mechanical Room south wall west of boiler behind 6-inch metal ducting pipe, between floor slab and wall.

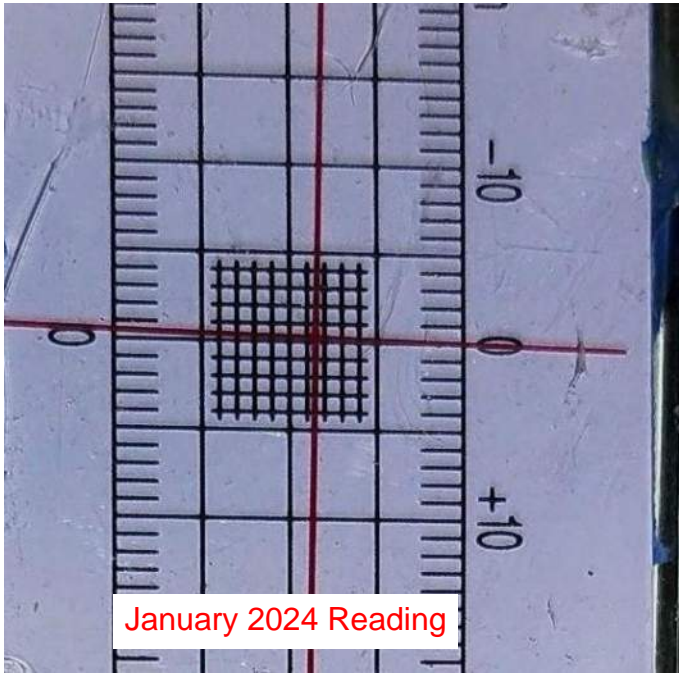
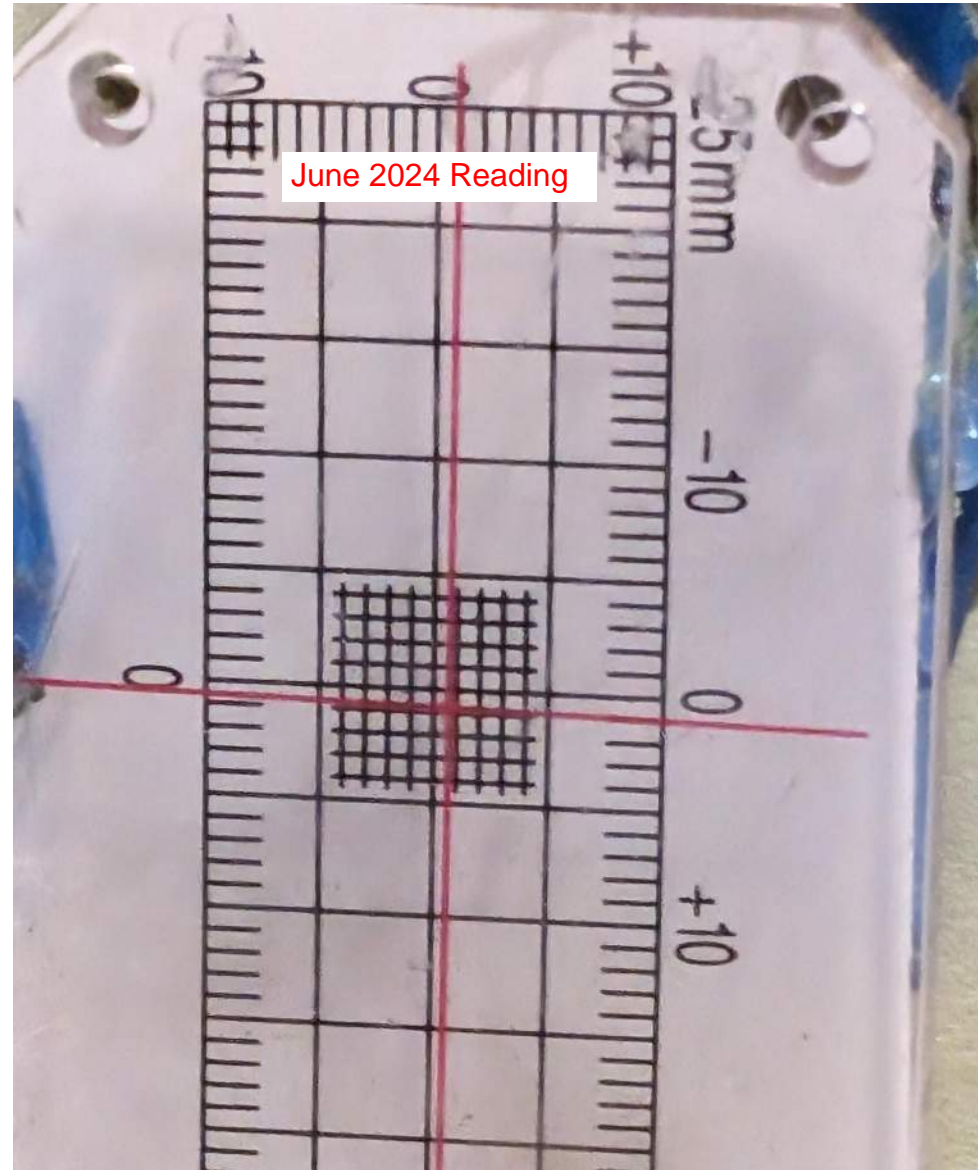
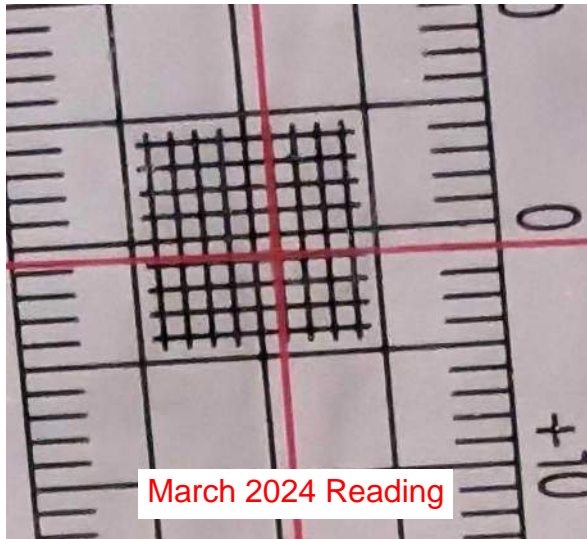
FIGURE 6

MP-5 - Water Tank room, west side of building just north of mechanical room accessed through exterior doors.
