RE: *Wayland Arms Apartments Structural Upgrade Summary – Auburn, Washington*

The purpose of this letter is to summarize our findings and recommendations from a structural standpoint that we have discussed with you previously.

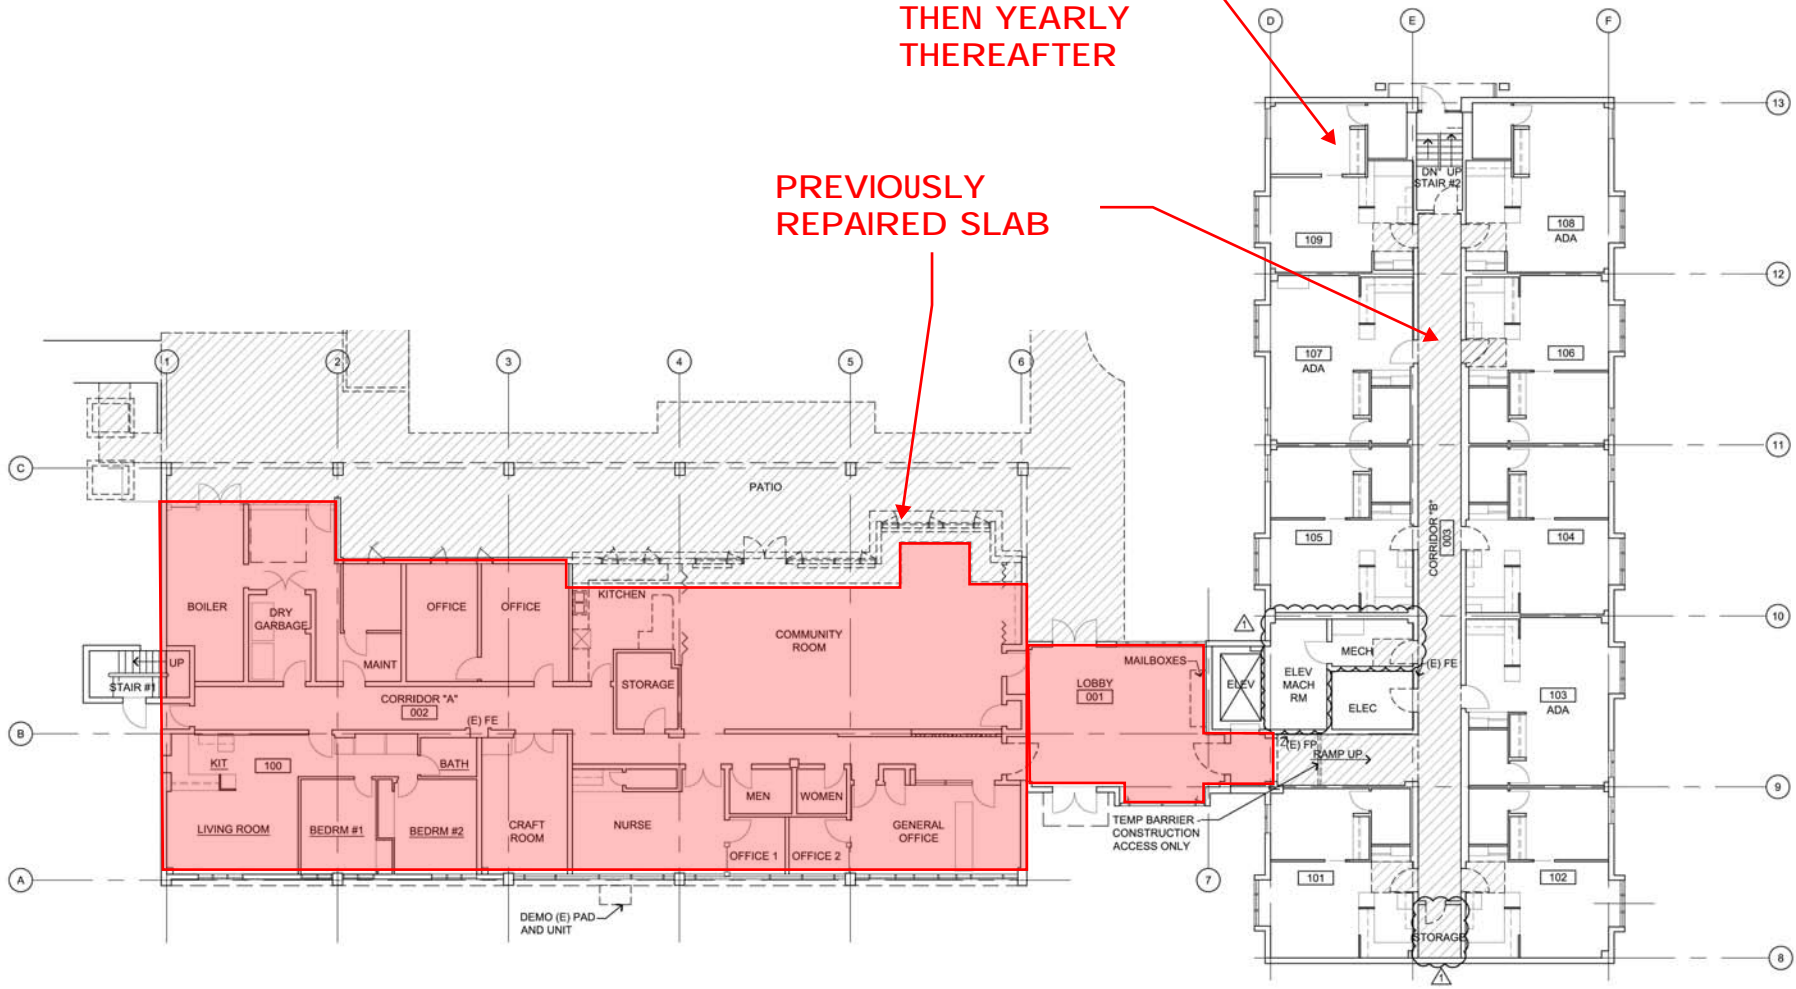
SLAB REPAIR SCOPE

- We observed 1" approximately of slab settlement at the south end of the building at the first floor. The non-bearing metal stud walls and masonry walls had gaps at the bottom of the walls and appeared to be suspended from the 2nd floor.

- In 2013, the first-floor corridor at the north end of the building was resupported with steel pin piles and concrete grade beams. We observed that the slab had settled approximately 1" similar as at the South wing. The non-bearing metal stud walls appeared to be suspended from the 2nd floor and had gaps below the wall.

SLAB TO BE MONITORED QUARTERLY INITIALLY AND THEN YEARLY THEREAFTER

PREVIOUSLY REPAIRED SLAB

- The existing slab could be replaced with a new structural slab with pin piles at the first floor. The interior partitions would need to be removed and re-installed. The corridor slab at the north building wing could remain as this is already supported. The existing utilities could be supported from the new structural slab. The scope of work would be similar to the 2013 work that was done. An alternate fix could be to re-shore all of the walls, but this would be a temporary fix.
- A voluntary seismic upgrade is highly recommended due to the overstressed steel moment frames. The upgrade options are as follows:
 - Option 1: Seismically upgrade only the first floor by adding steel buckling restrained brace frames.
 - Option 2: Seismically upgrade the entire building by adding steel buckling restrained brace frames to each floor.

Indicates location of new concrete structural slab with pin piles

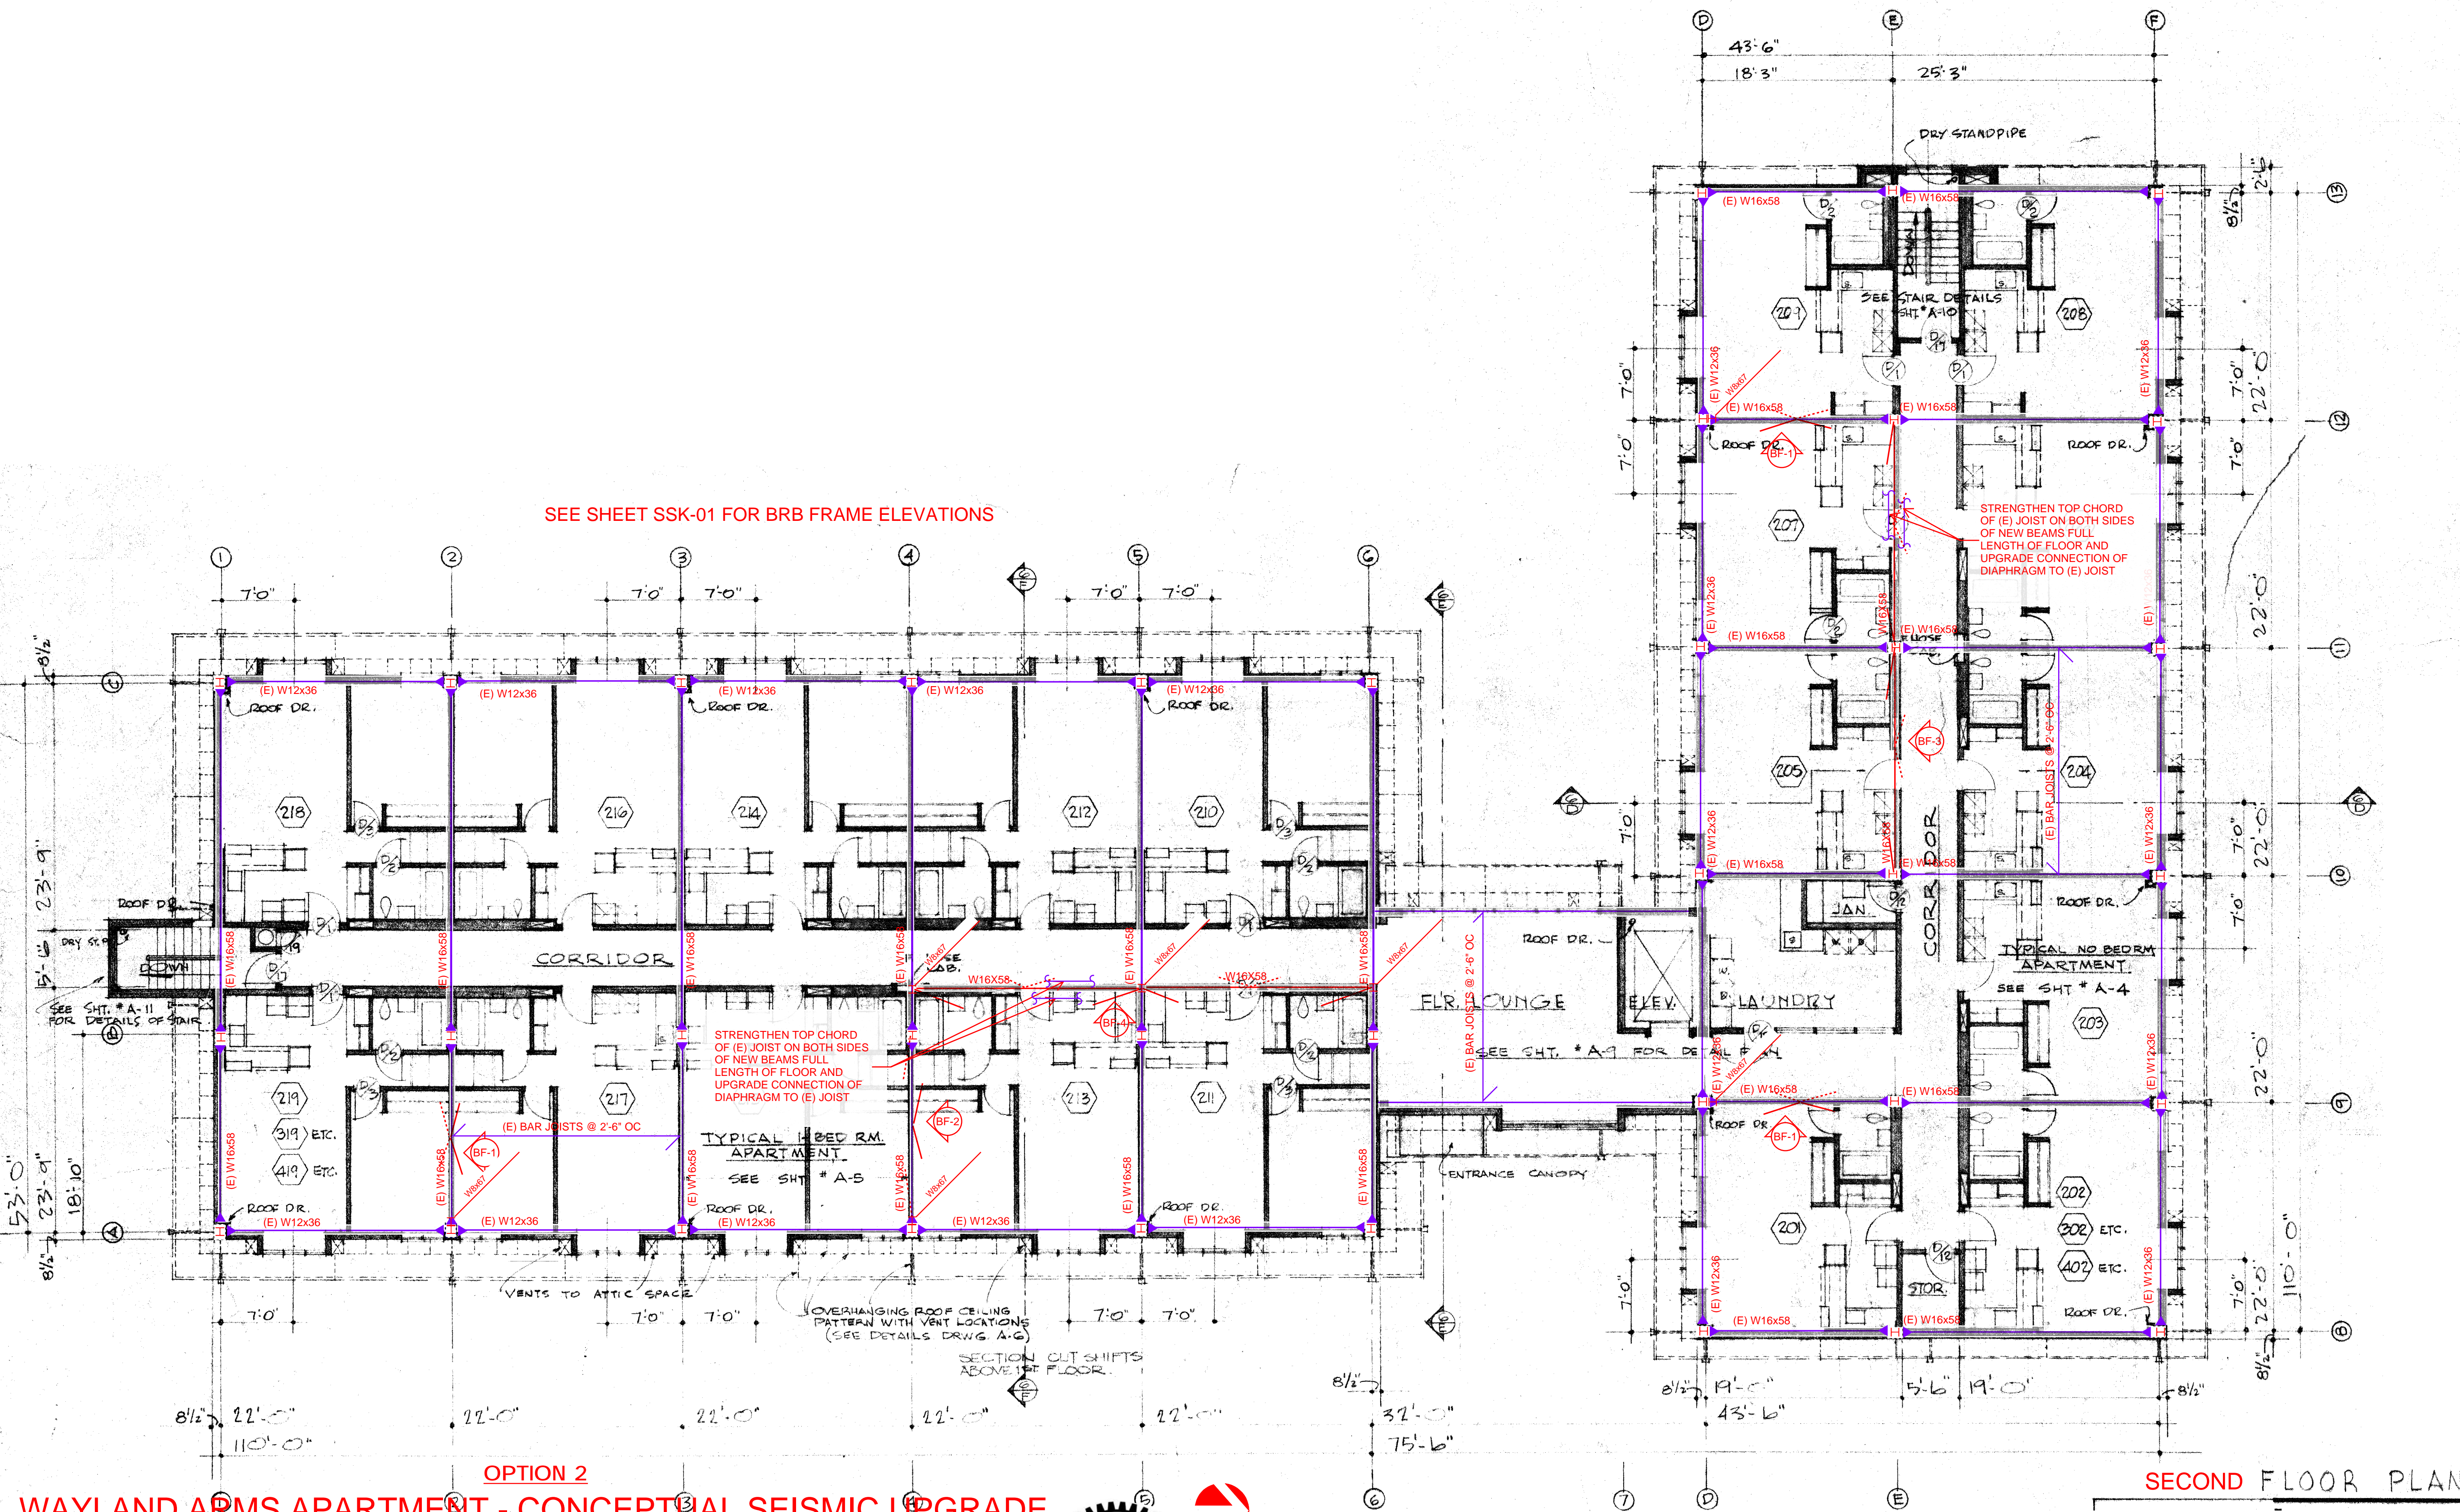
FOUNDATION PLAN 1/8"=1'-0"

- The steel moment frames are overstressed and do not meet the building code drift requirements from a lateral standpoint.
- No signs of settlement are being observed at the masonry veneer walls nor at the second and third floor. The main building is supported by timber piles and concrete grade beams.
