# FOR WAYLAND ARMS SLAB REPAIR & SEISMIC UPGRADE RFQ

<b>Project Name:</b>	Wayland Arms Apartments - Settlement Monitoring	<b>Report:</b> 003	
<b>GeoDesign #:</b>	KCHA-13-04	<b>Date:</b> 06/06/2024	
<b>Reports with Unresolved Nonconformance Issues:</b>		<b>Permit:</b>	
<b>Distribution:</b>	Heath MacCoy <HeathM@kcha.org>		
	David Curtice <DavidC@kcha.org>		
	Kevin Johnson <KevinJ@kcha.org>		
	Patrick Kaapana <PatrickK@kcha.org>		
	Michael Cuadra <MichaelC@kcha.org>		
	<b>Weather:</b> NA, indoors	<b>Arrival/Departure:</b> 0815/0840	<b>Prepared By:</b> Vinnie Oskierko
<b>Attachments:</b>	<input checked="" type="checkbox"/> Site Plan(s)	<input type="checkbox"/> Density Test Summary	<b>Signature:</b>
	<input type="checkbox"/> Installation Records	<input type="checkbox"/> Other	<b>Reviewed By:</b>

**SUMMARY OF CRACK MONITORING GAGE INSTALLATION AND READINGS:**

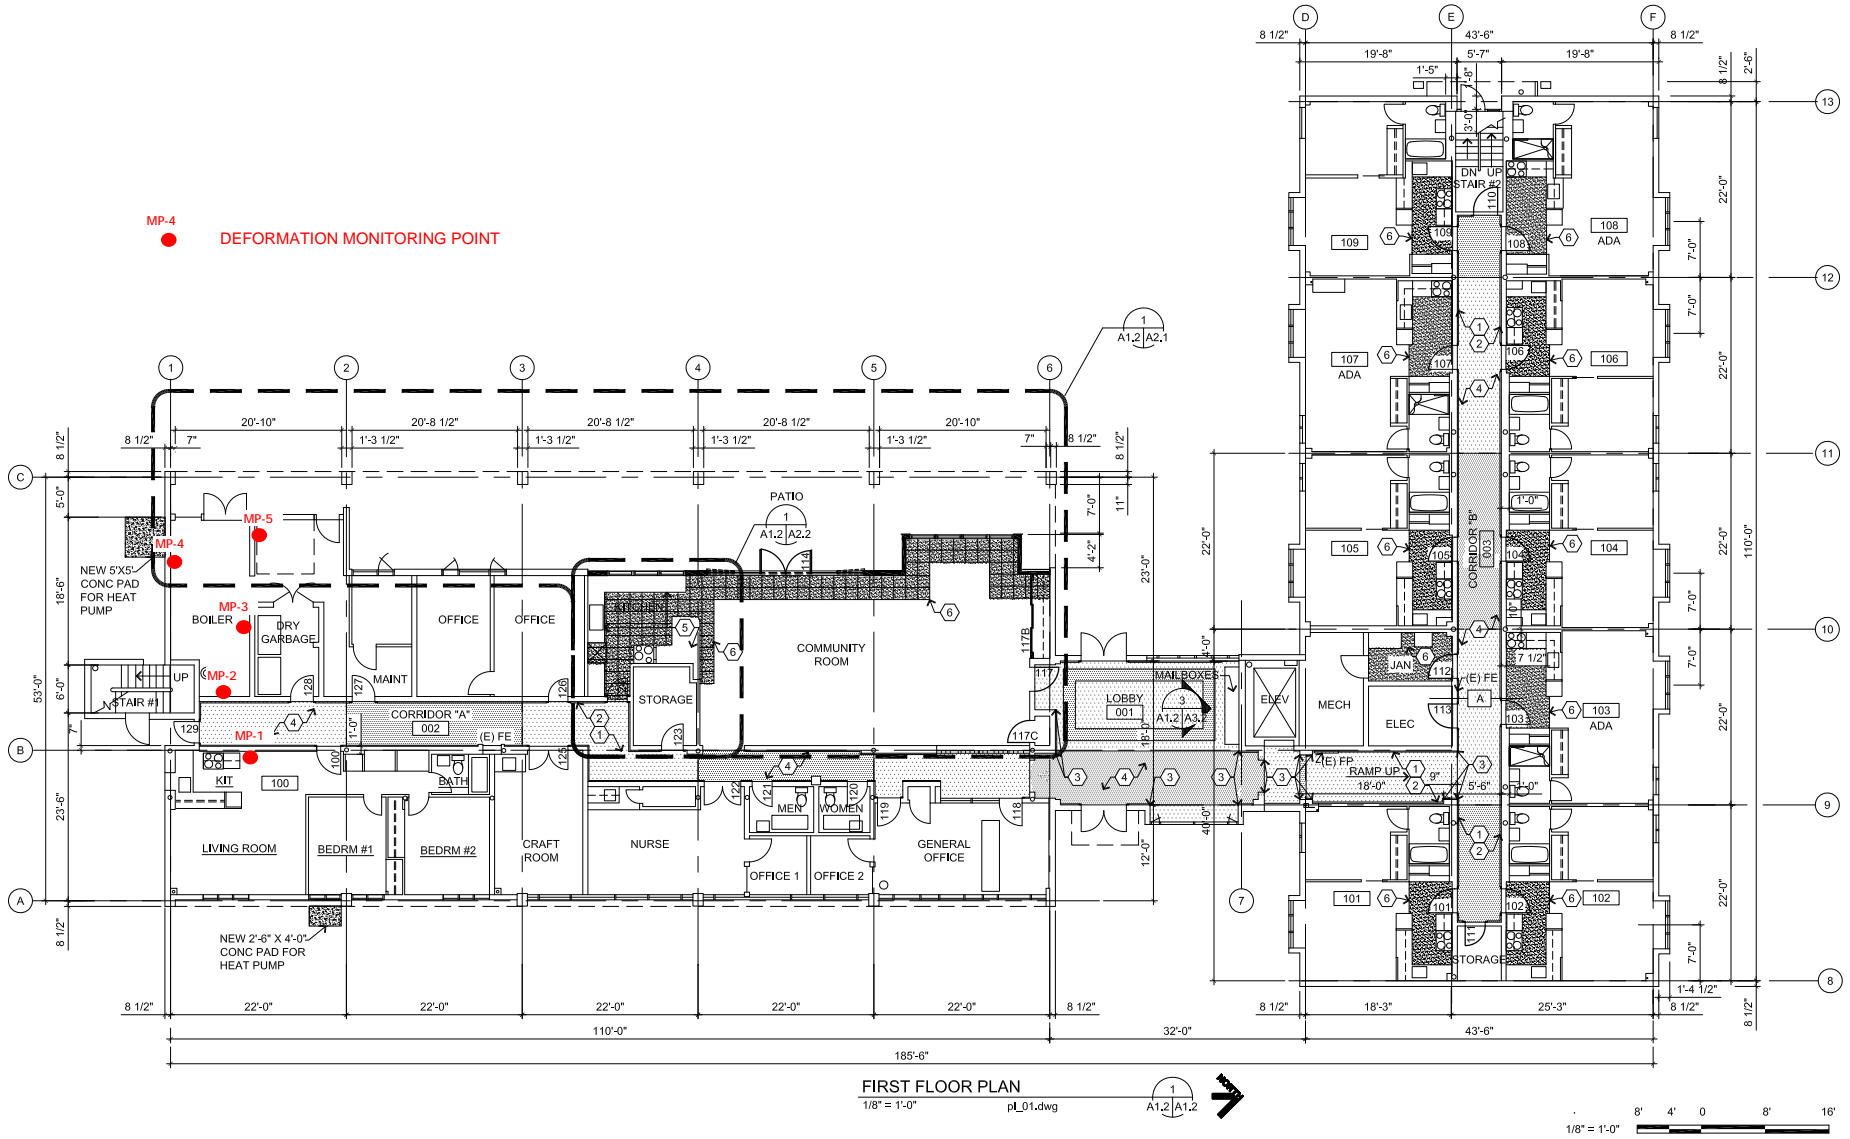
KCHA-13-04	MONITORING POINT LOCATIONS	
	JUNE 2024	WAYLAND ARMS APARTMENTS AUBURN, WA	FIGURE 1

Dec 7, 2023, NV5 installs 5 crack monitoring gages at Wayland Arms Apartments in Auburn at the following locations and as shown on Figure 1.

MP-1 - Suite 100 central wall opposite interior hallway between floor and wall stud. Wall studs are hanging from 2nd floor joist and there is an existing gap between the floor slab and base plate.

MP-2 - Mechanical room central wall opposite interior hallway, between floor and cinder block wall.

MP-3 - Mechanical Room north wall behind fire water pipes between floor slab and cinder block wall.

MP-4 - Mechanical Room south wall west of boiler behind 6-inch metal ducting pipe, between floor slab and wall.

MP-5 - Water Tank room, west side of building just north of mechanical room accessed through exterior doors.
